New York State Department of Transportation

Yellow Flag NB2222W017

BIN: 1065318
Feature Carried: 278I278IX2M23027
Feature Crossed: 6TH AVENUE
Orientation: 8 - NORTHWEST
Region: 11 - NEW YORK CITY
County: KINGS
Political Unit: City of NEW YORK
Approximate Year Built: 1962
Posted Load Matches Inventory : Yes
Bridge Load Posting (Tons) : Not Posted for Load
Primary Owner: New York State Department of Transportation
Primary Maintenance Responsibility: 12 - State - Subcontracted to another Party
Typical or Main Span Type: 3 - Steel, 02 - Stringer/Multi-Beam or Girder
This Bridge is not a Ramp
Number of Spans: 322

Location: Span 129, Girder G14 at Pier 128 over 3rd Avenue, Eastbound.

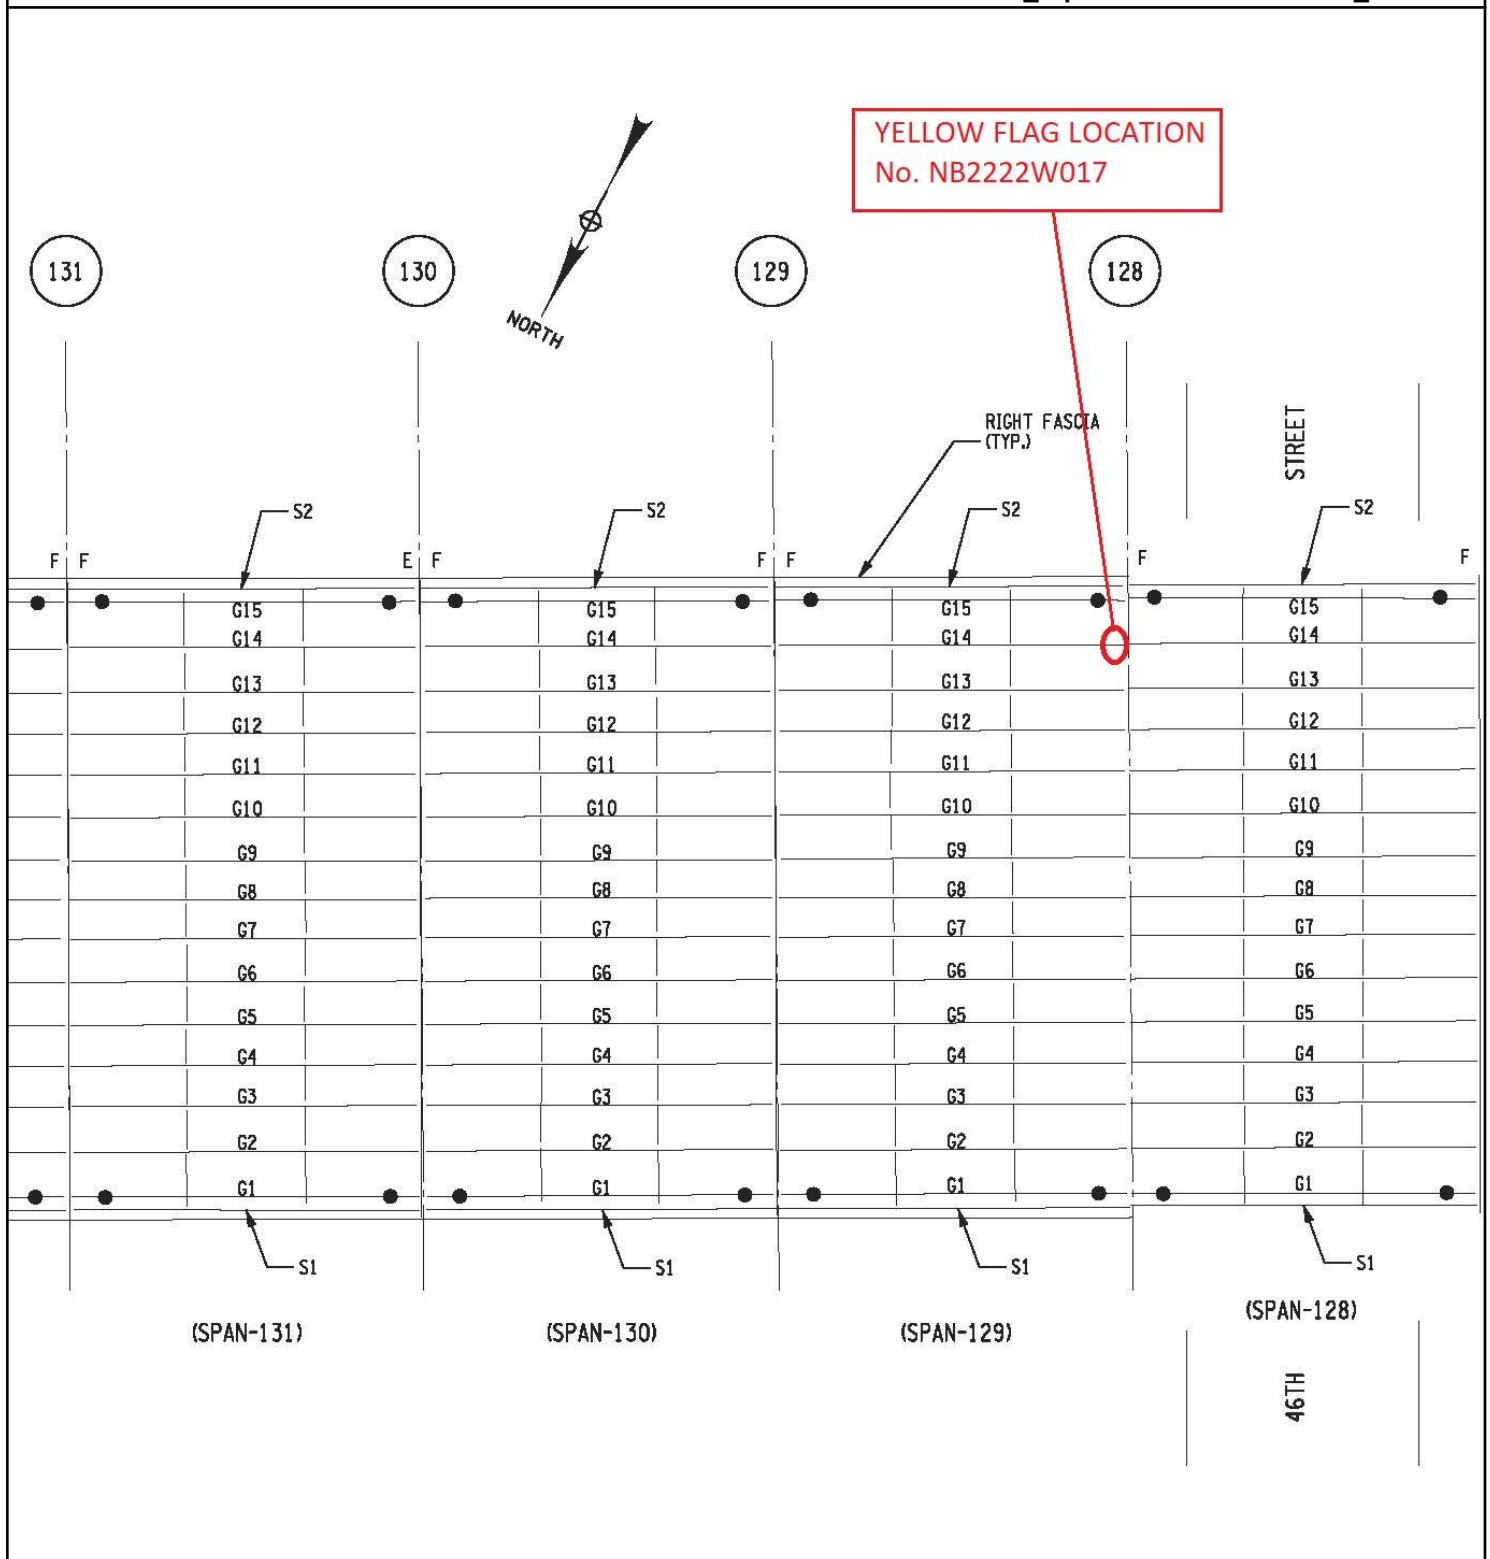
Photo Number: 1

**Attachment Description: General view of framing plan with defect location.**

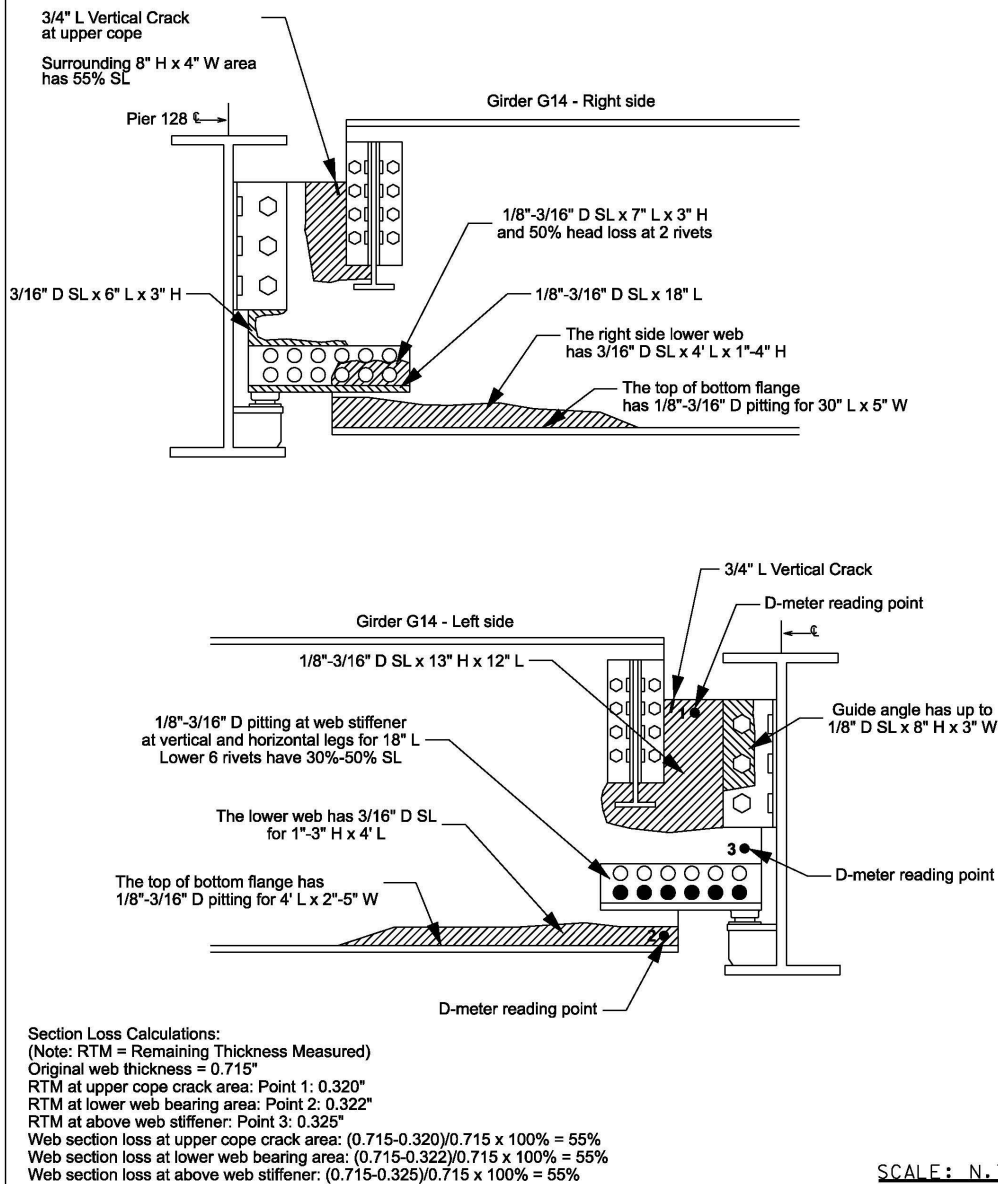
Photo Number: 2

Attachment Description: Sketch of defects at Girder G14 at Pier 128, Span 129.

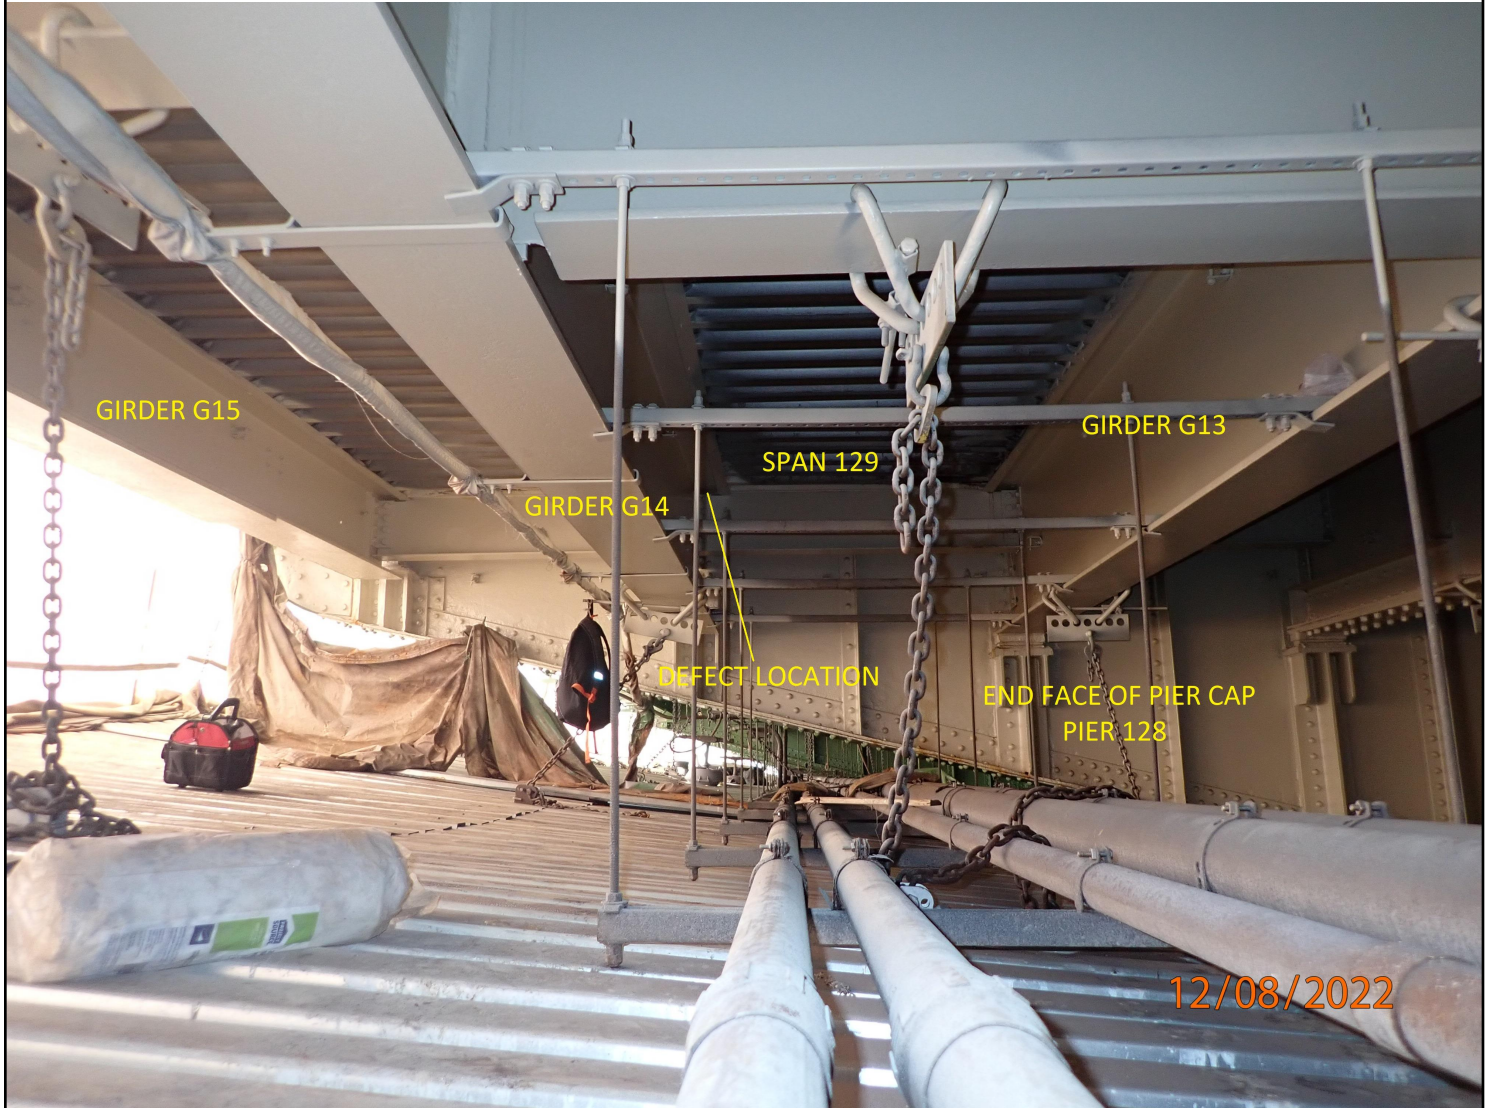
Photo Number: 3

Attachment Description: General view of flagged location, G14 at Pier 128, Span 129. Looking begin.

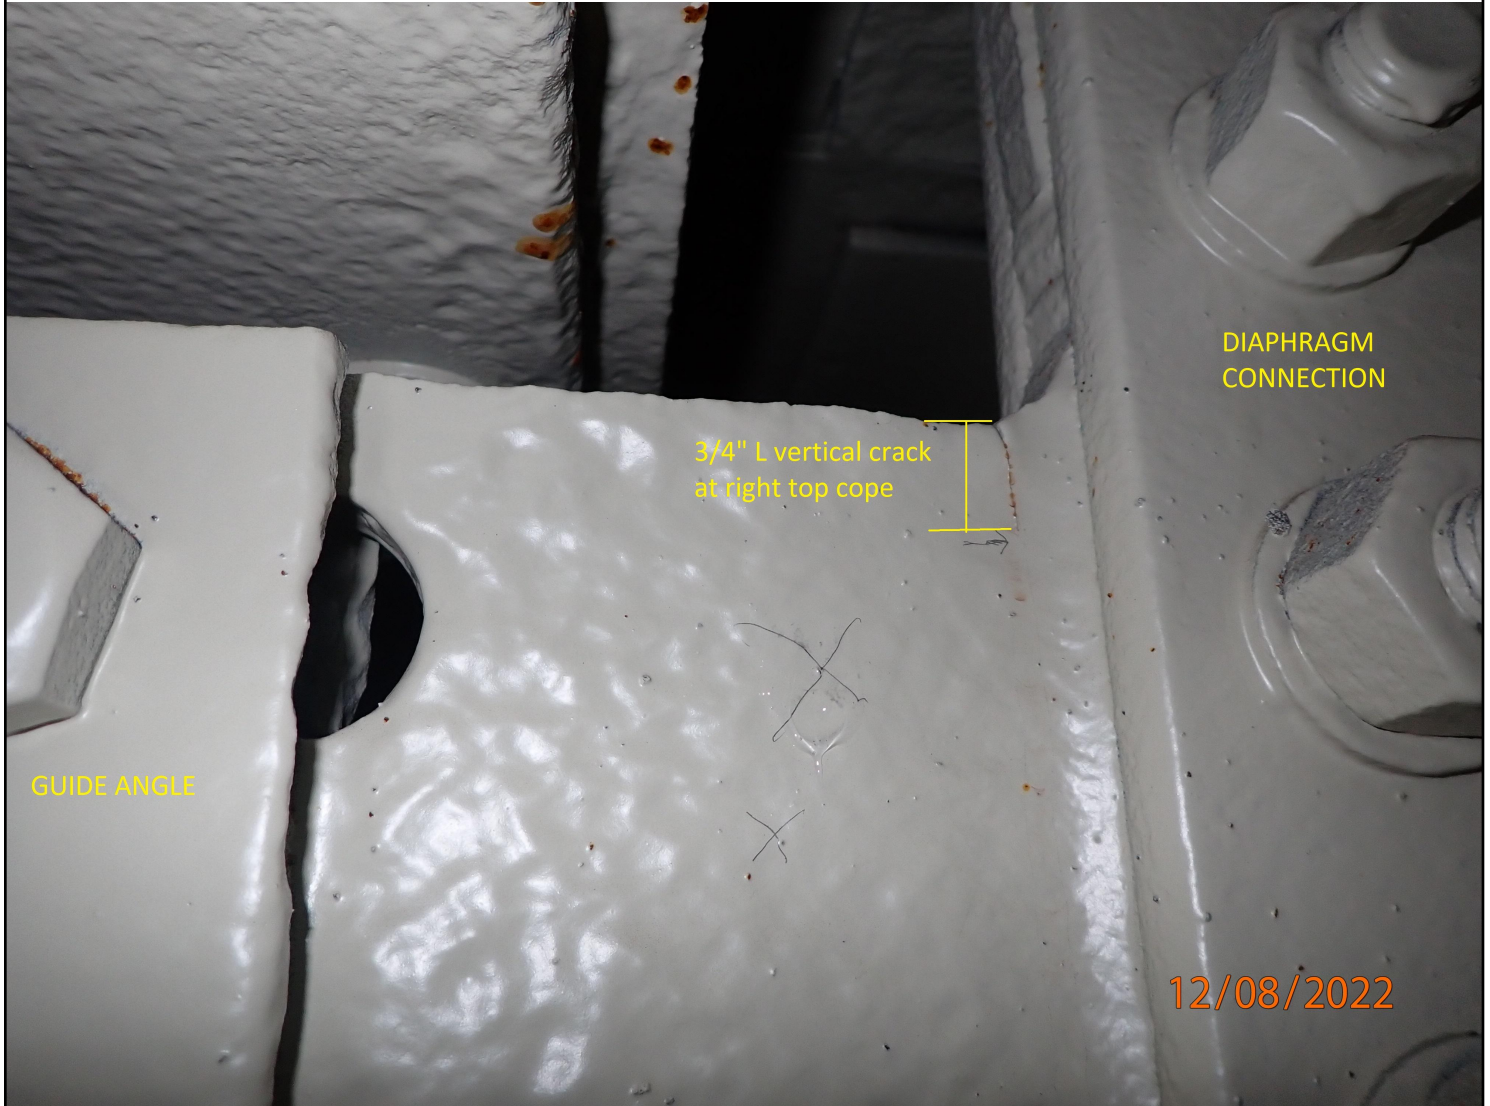
Photo Number: 4

Description: The end of Girder G14 in Span 129 at Pier 128 exhibits a 3/4" long vertical through crack in the upper web stemming from the top cope and extending downwards (Photos 4 & 5).

Attachment Description: Span 129, Girder G14 at Pier 128. The right side of web of Girder G14 at the top cope has a 3/4" L vertical crack. Looking left.

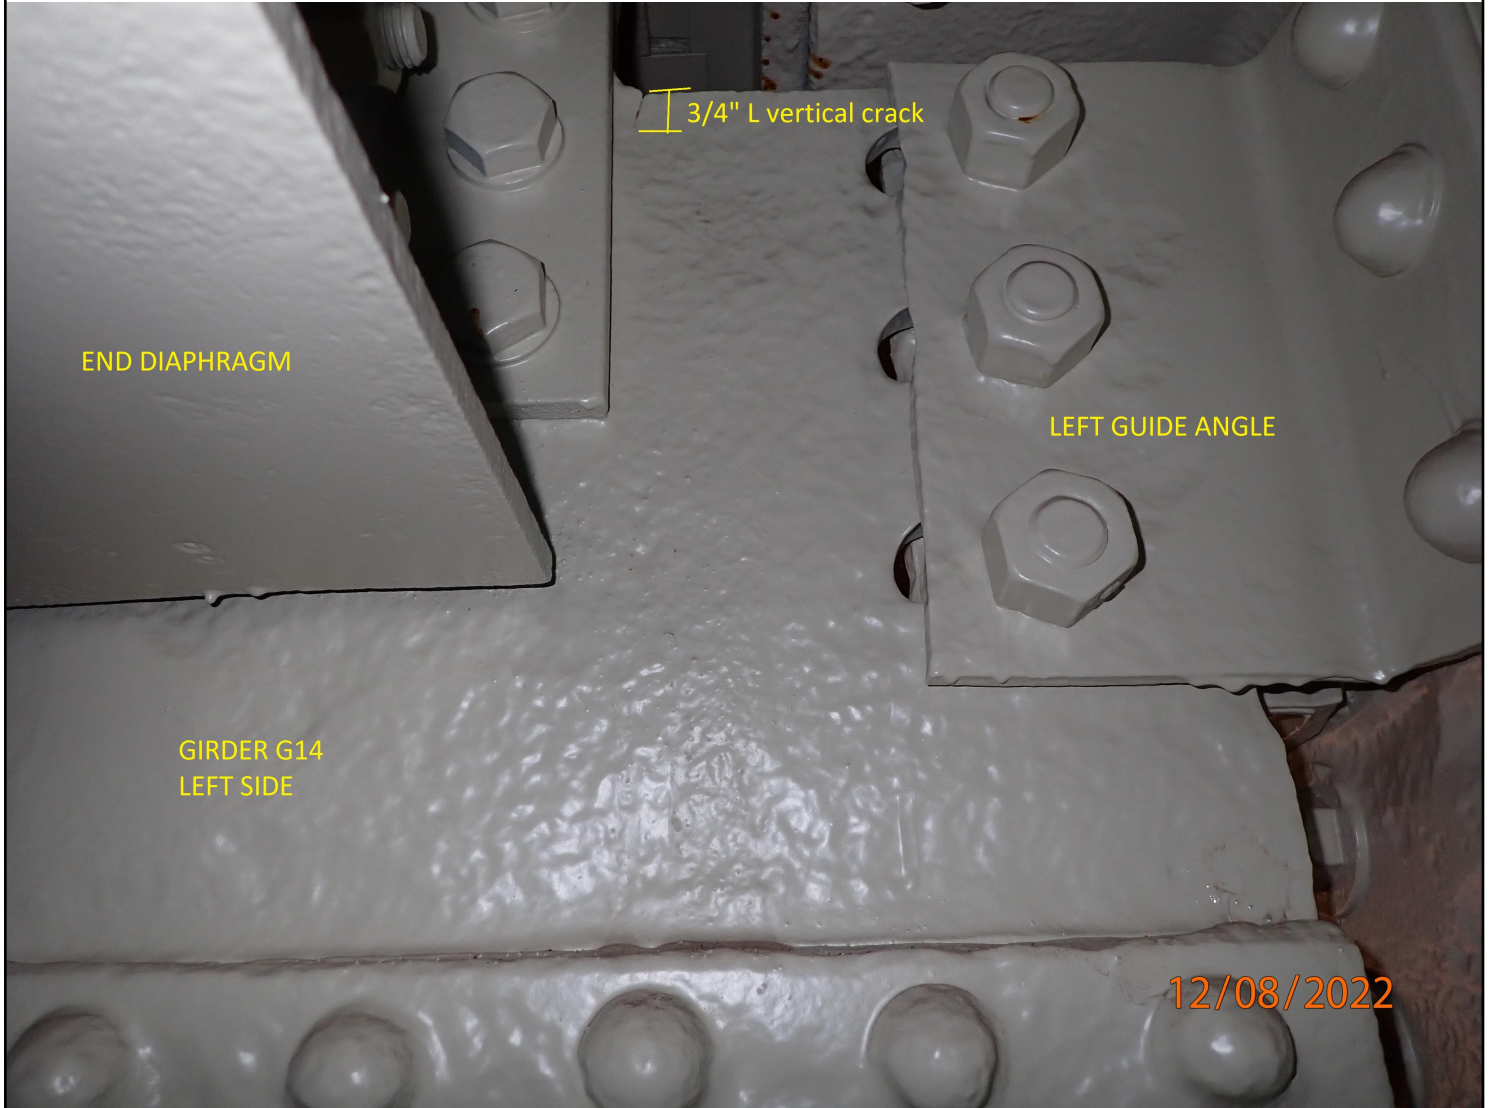
Photo Number: 5

In addition, the area surrounding the crack at the right side of the girder has up to 3/16" deep section loss over an 8" H x 4" W area and on the left side 1/8"-3/16" deep section loss over a 13" H x 12" W area (Photos 5 & 6). D-Meter readings indicate up to 55% section loss. The lower right side of web has up to 3/16" deep section loss for 4' L x 1"-4" H and the lower left side of the web has up to 3/16" deep section loss for 4' L x 1"-3" H (Photos 7 & 8). D-Meter readings indicate up to 55% section loss. The top of the bottom flange at the left and right sides has 1/8"-3/16" deep pitting for 30"- 48" L x 2"-5" W (Photo 9). The web stiffener angle at the right side has 1/8"-3/16" deep section loss at the vertical leg for 7" L x 3" H and the bottom flange has 1/8"-3/16" deep pitting for 18" L x 5" W. The horizontal web stiffener at the left side has 1/8"-3/16" deep section loss for 18" L and the 6 lower rivets have 30%-50% section loss (Photo 9). The left side guide angle has 1/8" deep section loss x 8" H x 3" W.

Attachment Description: Span 129, Girder G14 at Pier 128. The left side of the web of Girder G14 at the top cope has a 3/4" L vertical crack and the surrounding 13" H x 12" W area has up to 3/16" D section loss. Looking right.

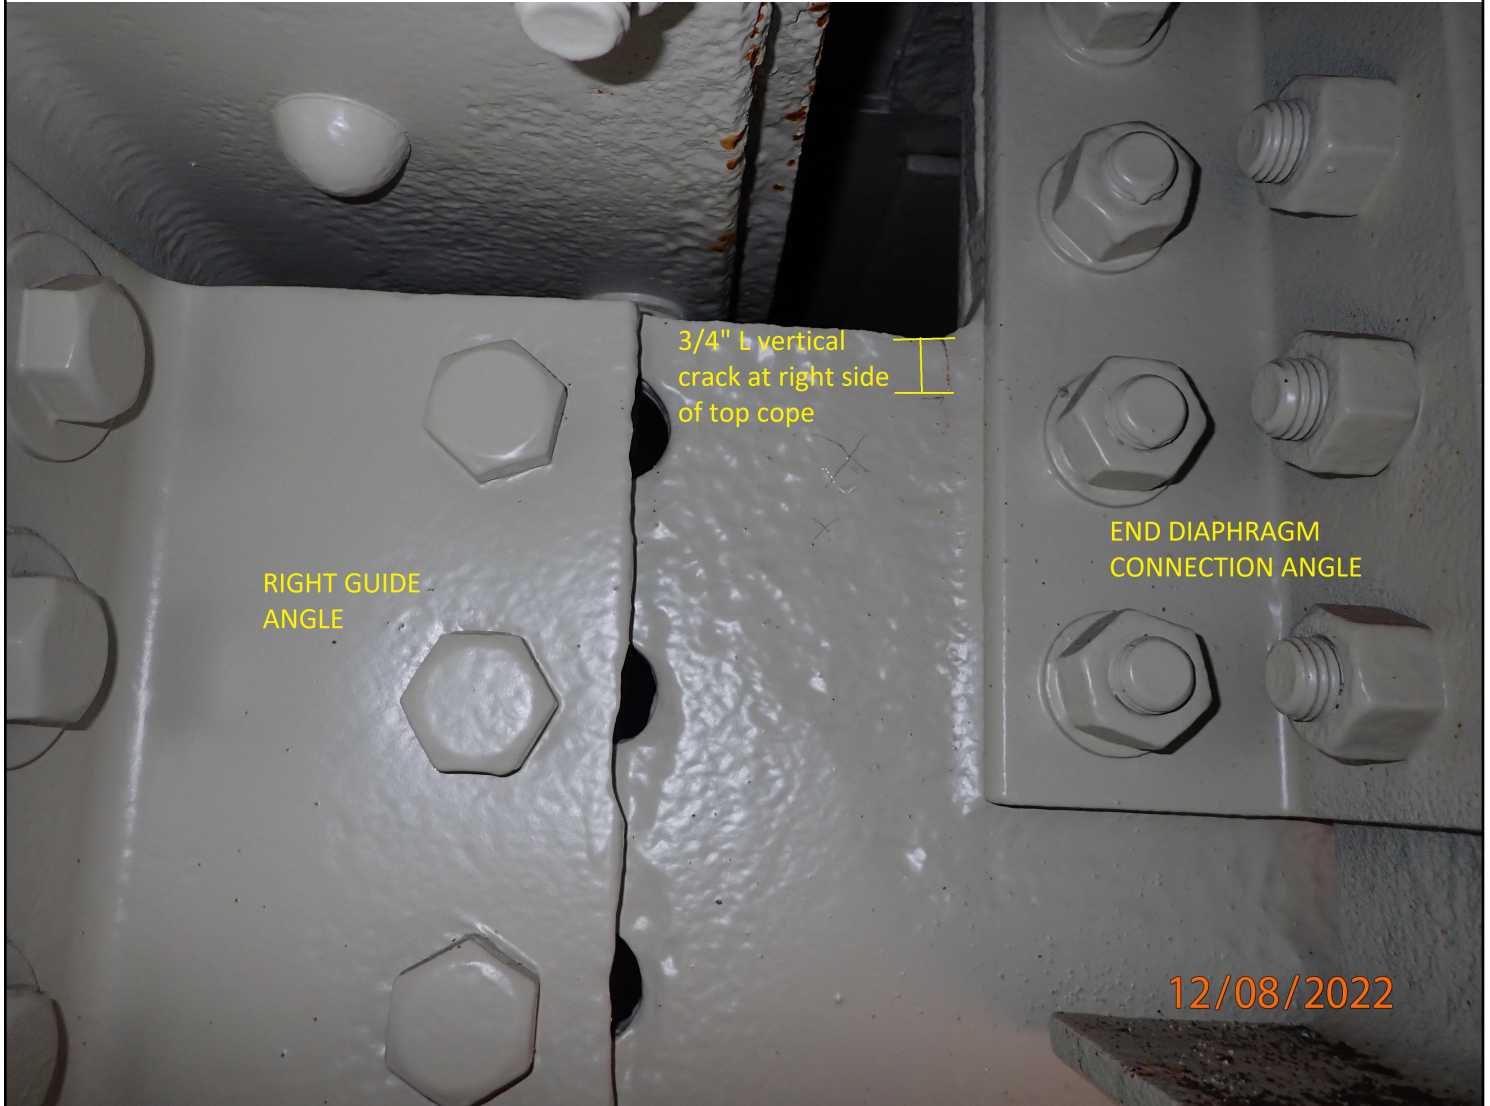
Photo Number: 6

Attachment Description: The area surrounding the crack at the right side of Girder G14 has up to 3/16" D section loss over an 8" H x 4" W area. Looking left.

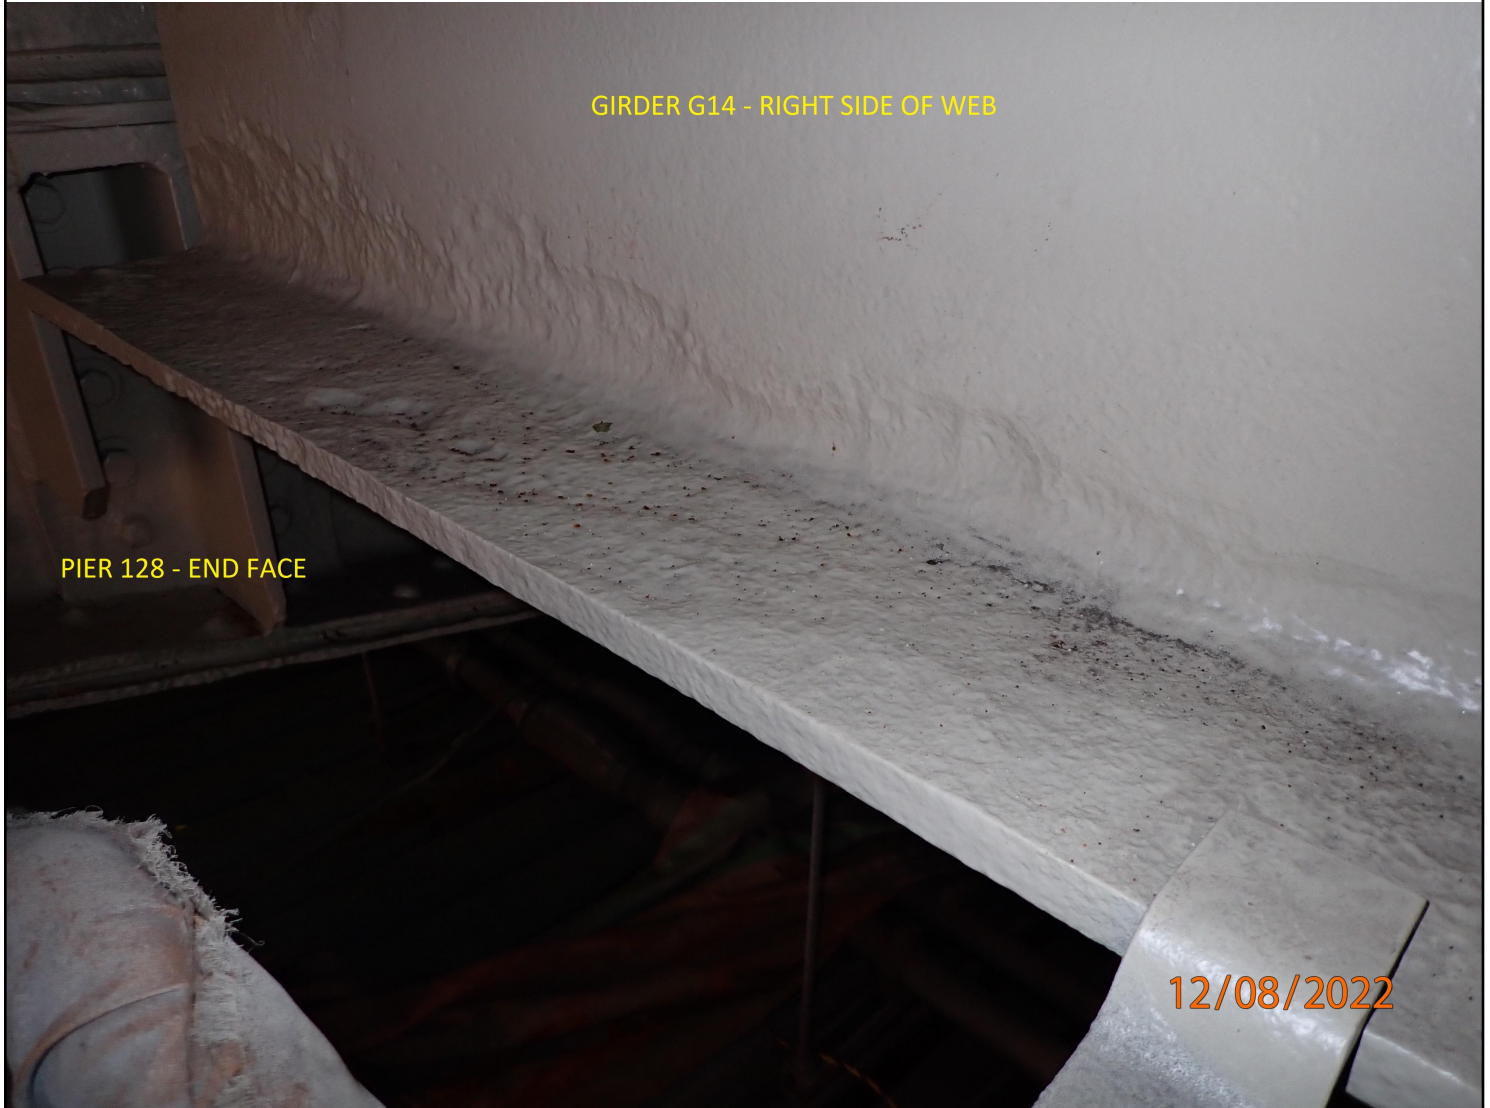
Photo Number: 7

Attachment Description: The lower right side of web above the bottom flange of Girder G14 has up to 3/16" D section loss for 4' L x 1"-4" H. Looking begin left.

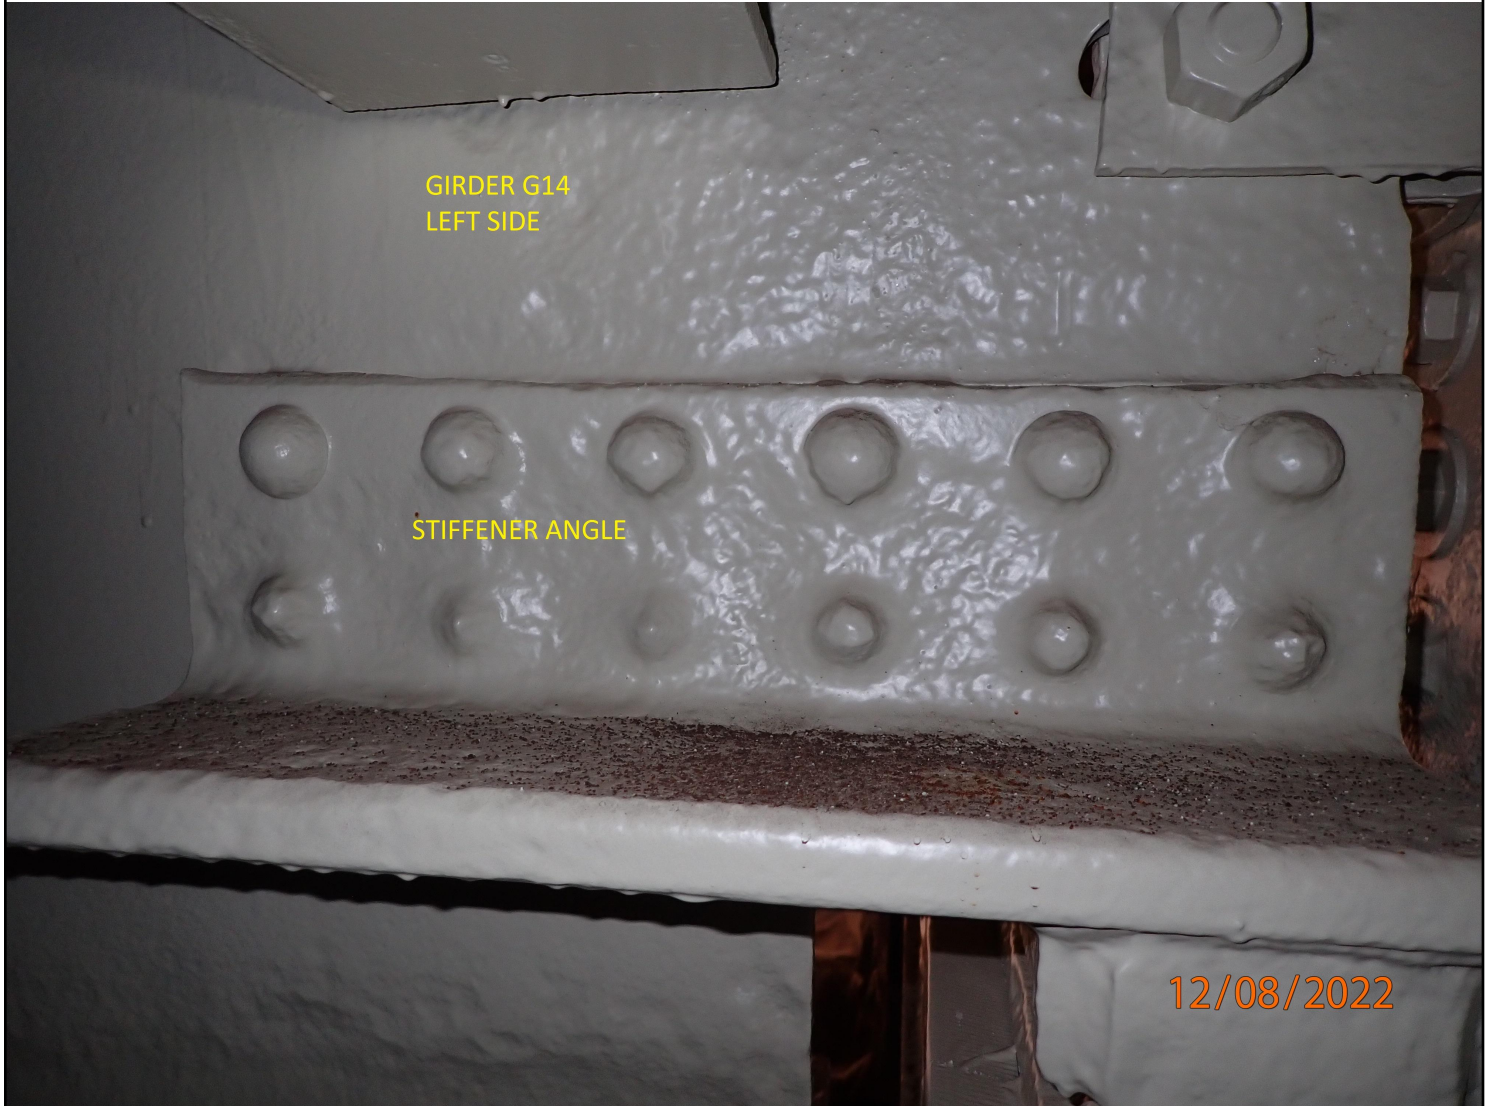
Photo Number: 9

Attachment Description: The left web stiffener angle of Girder G14 has 1/8"-3/16" D section loss for 18' L and the 6 lower rivets have 30%-50% section loss. Looking right.
